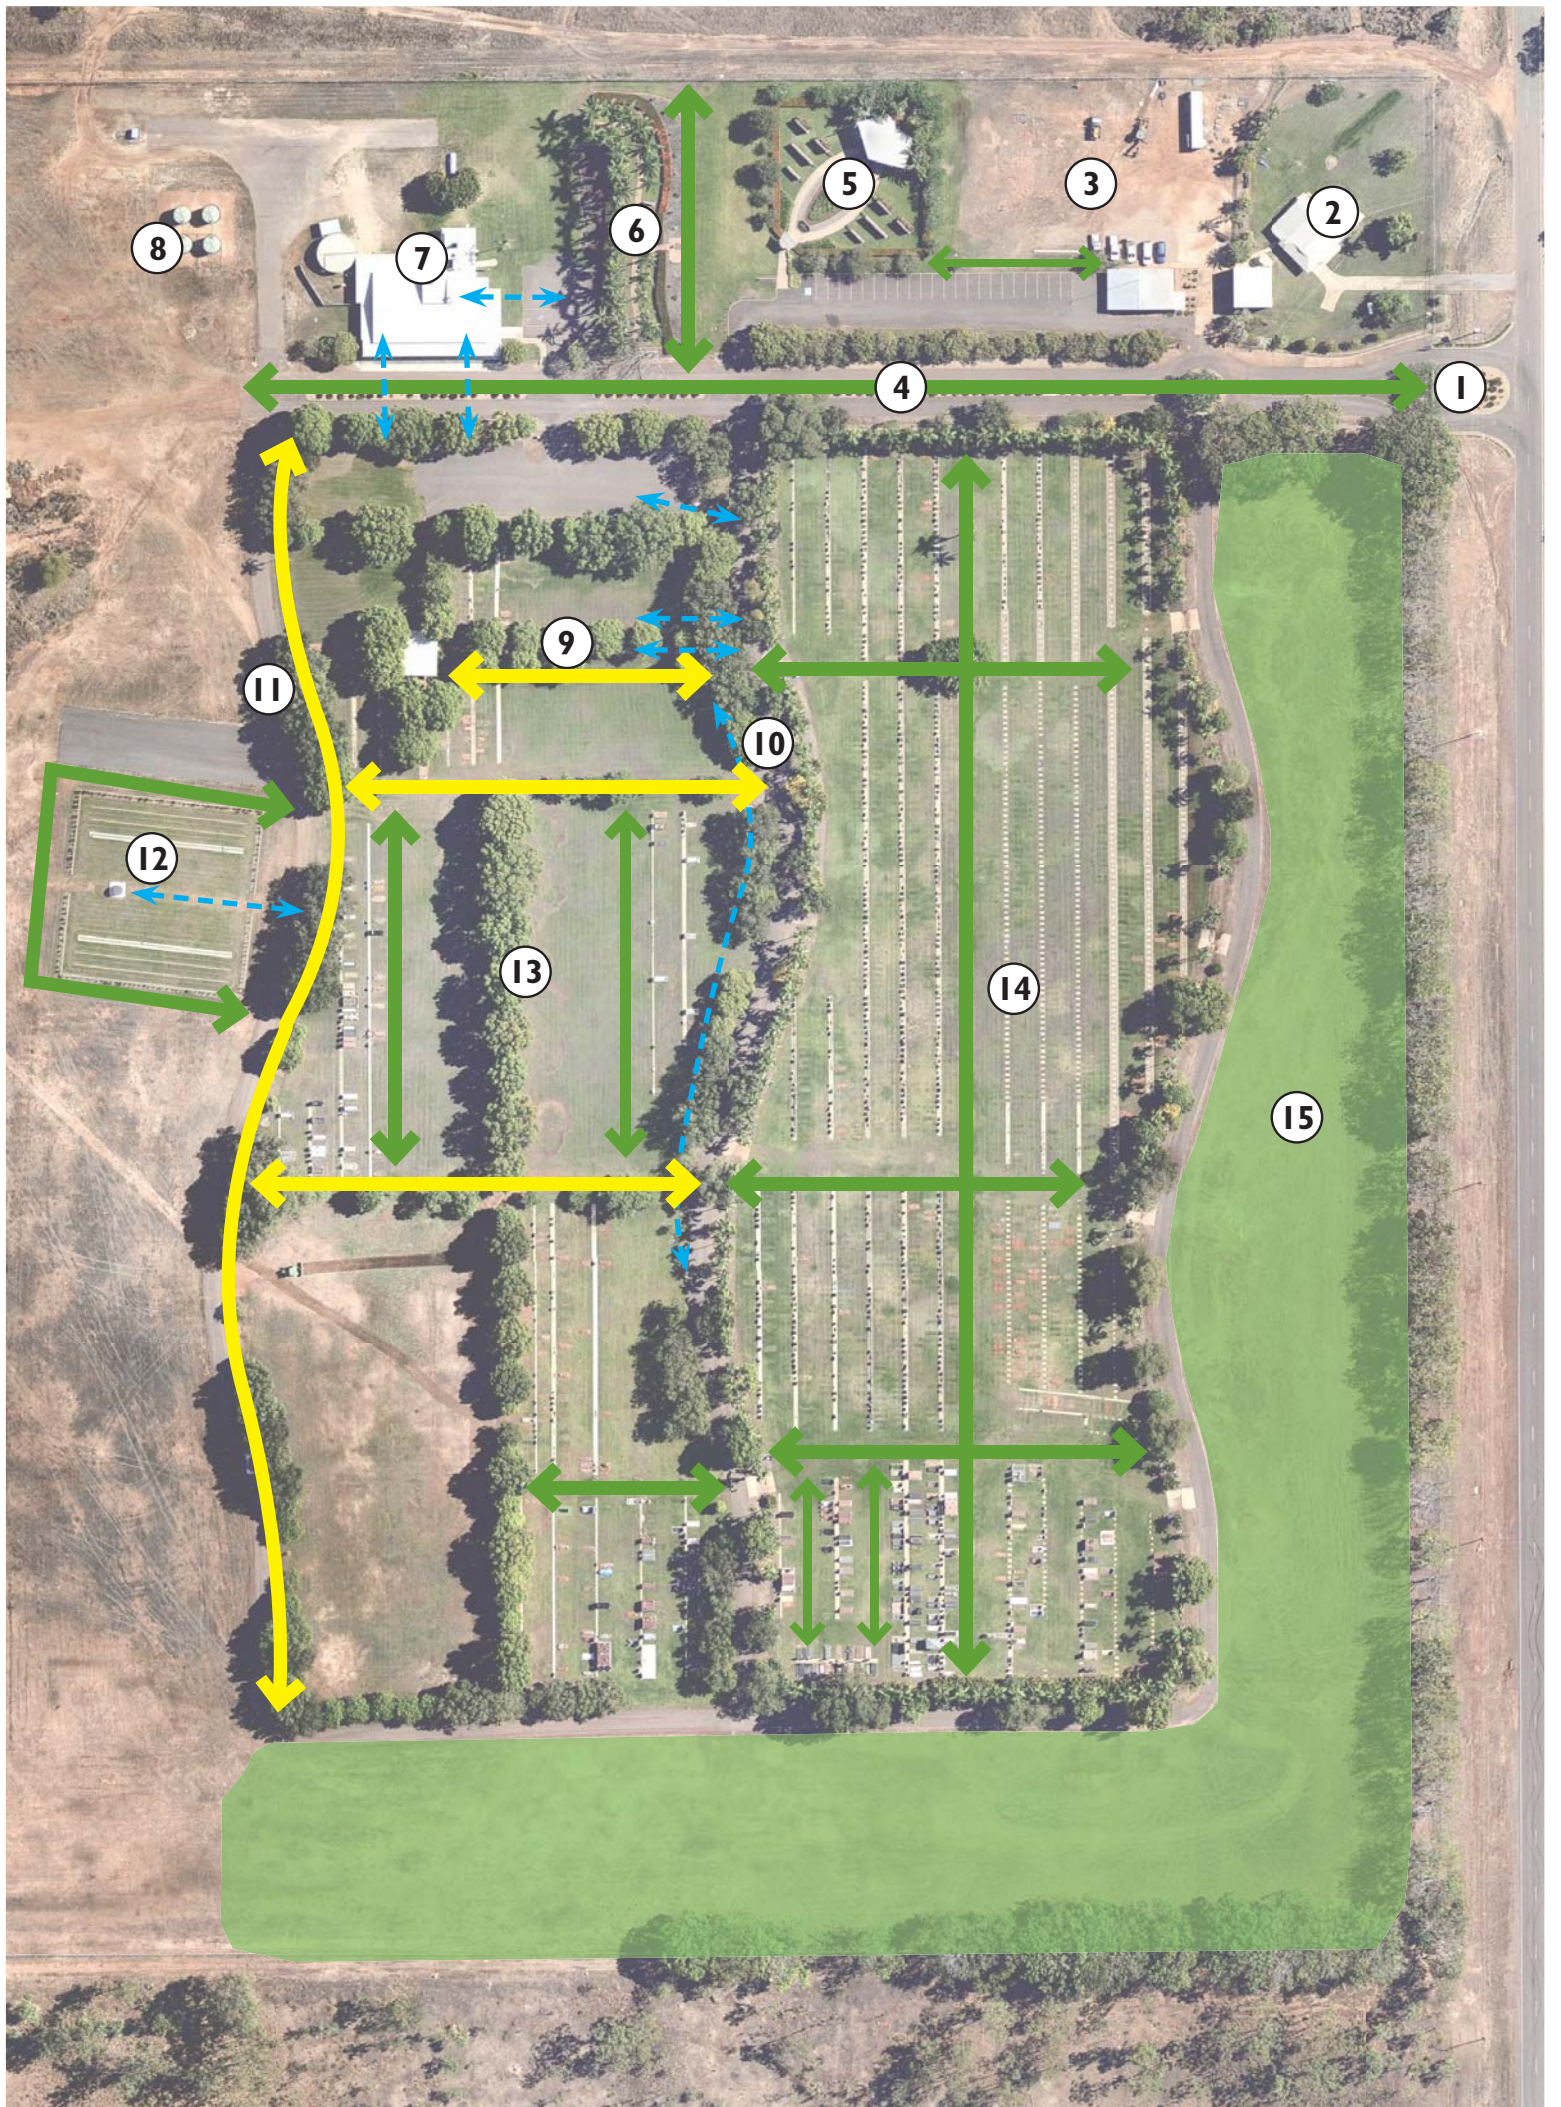
- Sense of arrival is cluttered with varying forms of signs and dense landscaping. Opportunity to 'open up' and create an inviting entry utilising contemporary materials and finishes;
- boundary fences match surrounding defence fences, opportunity to differentiate.

- Opportunity to provide landscaped gardens along the entry road to define public and private spaces while maintaining views for security purposes.

- Service and maintenance yard detracts from entry;
- Opportunity to provide screening to service yard from carpark and main road.

- Roundabout obscures views and detracts from the entry;
- Opportunity to open up and strengthen the axis of the main entry road using a central avenue trees planting;
- Opportunity to include wayfinding signage.

- Appropriate surrounds and landscape approach;
- Sets an architectural and design standard that could be applied to other areas within the cemetery.

- Garden appears dated, paving is deteriorating and seating is in full sun;
- Opportunity to upgrade paving and provide large shade trees and new planting to both sides of the garden;
- Provision for seating in shaded areas for quiet reflection;
- Long views through barbed wire and chain mesh fence to un-maintained grassland in future expansion area.

- Limited spill out space from the chapel under all weather cover.
- Ensure all entries and gathering spaces allow for disabled access.
- No differentiation of public and service areas between the chapel and crematorium;
- Views through from memorial garden to the back of house and service entry of the crematorium.

- Views through to the Back of House and service areas including tanks;
- Opportunity to introduce screening and differentiate public and service areas.

- Restricted disabled access throughout area;
- Long views down path corridors don't match up with current viewsheds down adjacent section of cemetery;
- Damaged tree corridors - missing trees;
- Opportunities for more shade tree corridors throughout area;
- Bin and pond pump at Area of Reflection detract from visual amenity. Opportunities to provide vegetative screening or enclosures.

- Some avenue trees missing, haphazard understorey planting, opportunity to upgrade;
- General public vehicle access to road is not allowed. Currently a removable bollard (not lockable) denies access;
- Irrigation pipes visible along the edge of road;
- Road generally shady and used as pedestrian path. Palm planting along one side.

- Avenue trees planted along one side of road, opportunity to improve pedestrian shade by planting trees on other side;
- No formal access to cemetery areas from this road - primarily used for maintenance access.

- Recent planting along boundaries; no tree plantings in this space. Opportunity for trees throughout area;
- Unmaintained gravel access to memorial in centre of area, resulting in restricted disabled access;
- Adjacent car parking not lined.

- Existing shade trees along boundary of space missing several trees (some stumps remain). Opportunity to plant new shade species and increase number of shade tree avenues throughout space;
- Bins in this area detract from visual amenity; opportunity to enclose.

- Vehicle access points to grave site areas defined by concrete layover. Blocked by chain attached to two steel posts;
- bins located at vehicle entry points and detract from visual amenity. Option to house in bin enclosures;
- Grave site areas are void of shade apart from edges of space. Opportunity exists for tree planting in rows where space allows;
- No apparent directional signage.

- Opportunity for a walk-through woodland/quiet landscaped area for memorial plaques, statues and the scattering of ashes.
